## Sample Home Inspection Report

Property address: **12345 Main St.  
Winnipeg MB R1R 0R0**

Inspection date: **Friday, March 1, 2024**

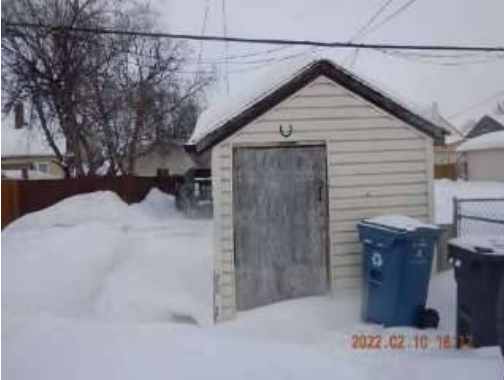
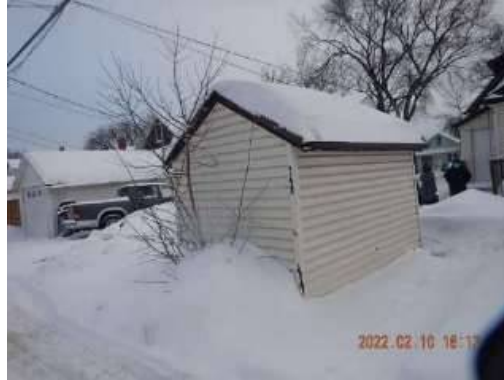
1) **Comment** - No outbuildings or detached structures were evaluated. They are excluded from this inspection.

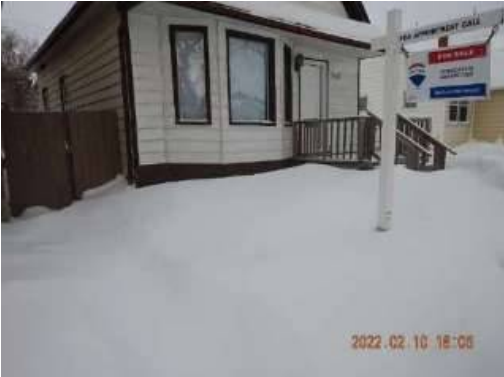
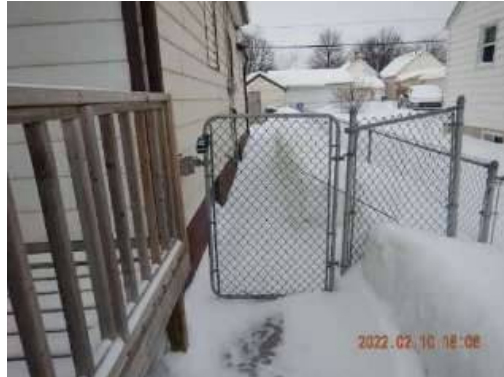
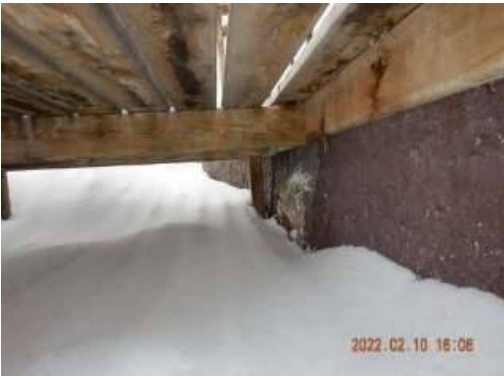
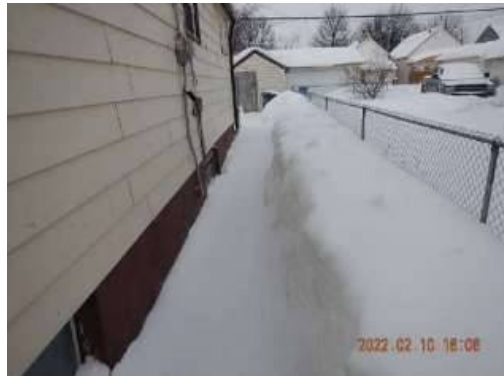
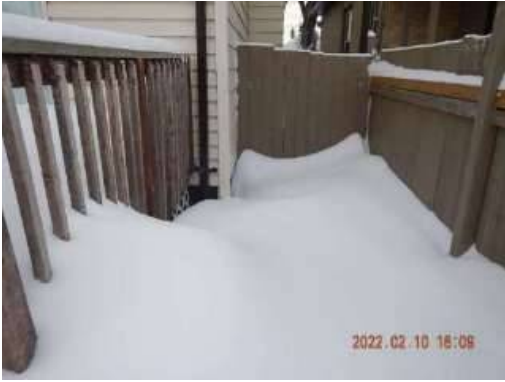
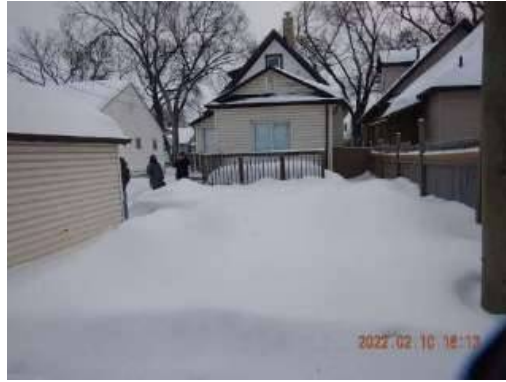
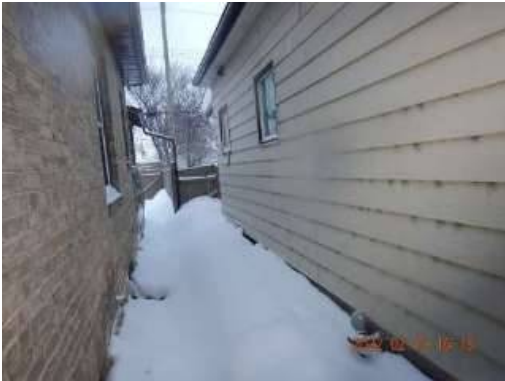
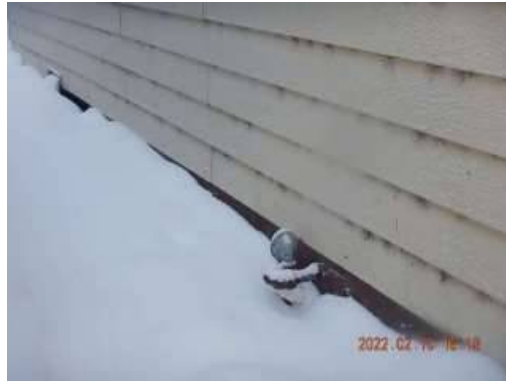
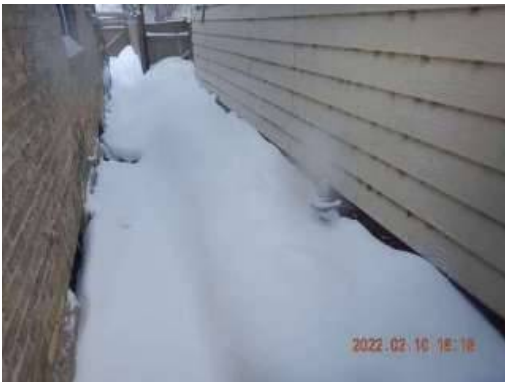
2) **Comment** - Most areas of the driveway, sidewalk and patio were obscured by snow and couldn't be fully evaluated.

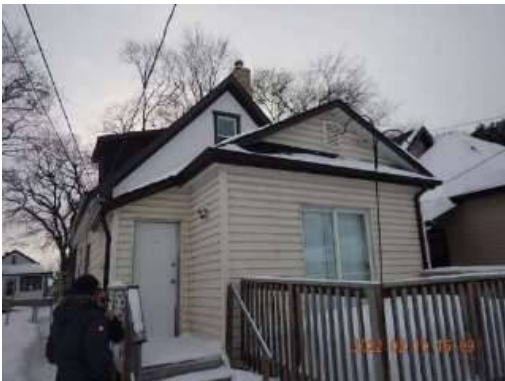
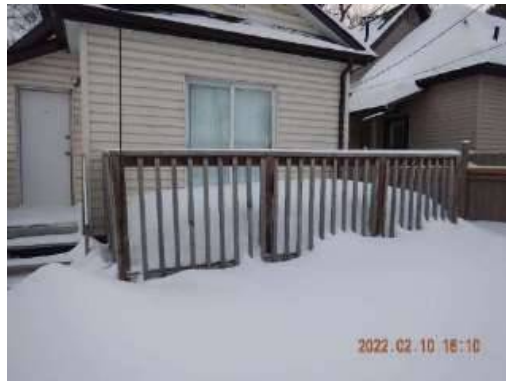
3) **Comment** - Some decks were obscured by snow. These areas couldn't be evaluated and are excluded from the inspection.

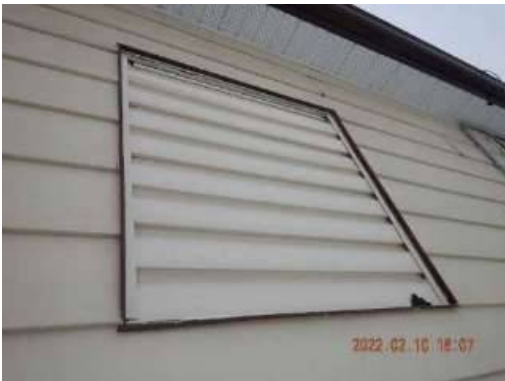
Photo 4-1

**4) Repair/Replace** - Some sections of cladding, siding and/or trim were damaged and/or substandard. Recommend that a qualified person repair, replace or install cladding, siding or trim as necessary.

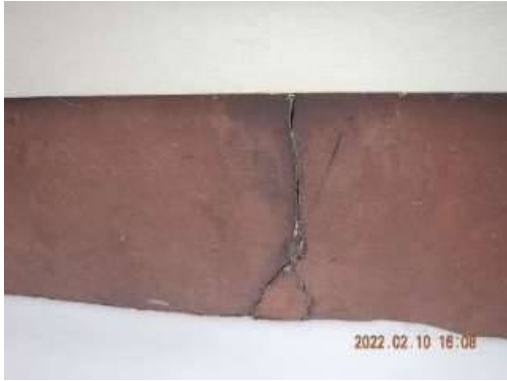
Photo 5-1

**5) Repair/Maintain** - One or more minor cracks (1/8 inch or less) were found in the foundation. These didn't appear to be a structural concern, but recommend sealing them to prevent water infiltration and monitor them in the future. Numerous products exist to seal such cracks including hydraulic cement, non-shrinking grout, resilient caulks and epoxy sealants.

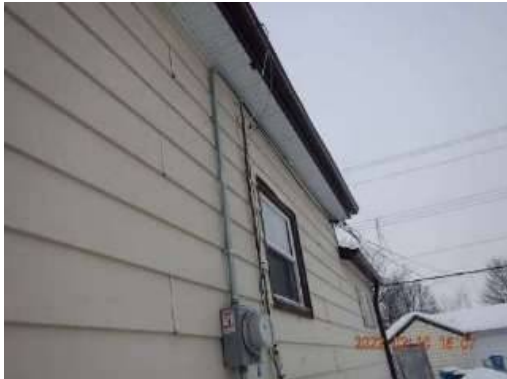
Photo 6-1

**6) Maintain, Conducive conditions** - Caulk was missing, deteriorated and/or substandard in some areas. For example, around windows, around doors, at siding butt joints, at siding-trim junctions and/or at wall penetrations. Recommend that a qualified person renew or install caulk as necessary. Where gaps are wider than 1/4 inch, an appropriate material other than caulk should be used. For more information, visit:

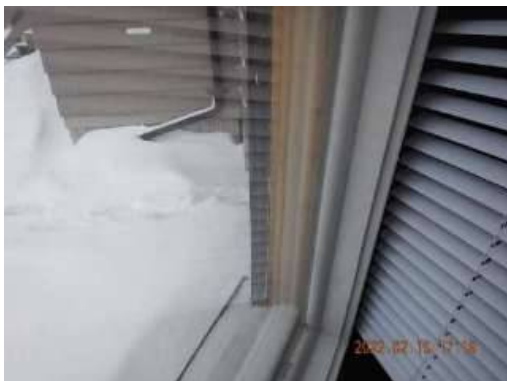
Photo 7-1

**7) Maintain, Conducive conditions** - Some areas of the exterior paint or stain finish were incomplete and/or substandard (e.g. primed only, too few coats). Recommend that a qualified contractor prep (e.g. clean, scrape, sand, prime, caulk) and repaint or restain the exterior where necessary and per standard building practices. Any repairs needed to the siding or trim should be made prior to this.

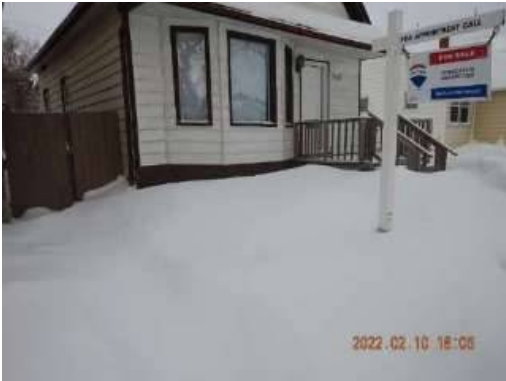
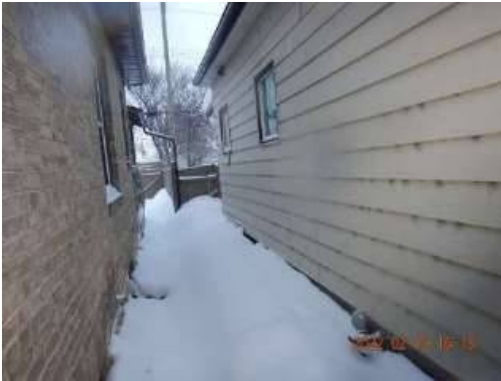
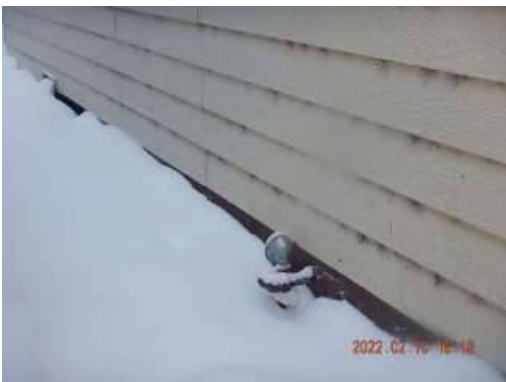
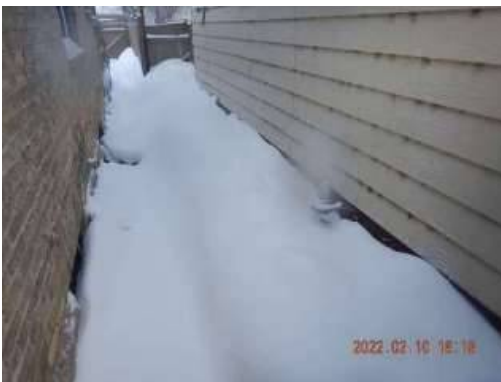
9) **Comment** - Some above-grade foundation walls were obscured by snow. The inspector was unable to evaluate these areas. They are excluded from this inspection.

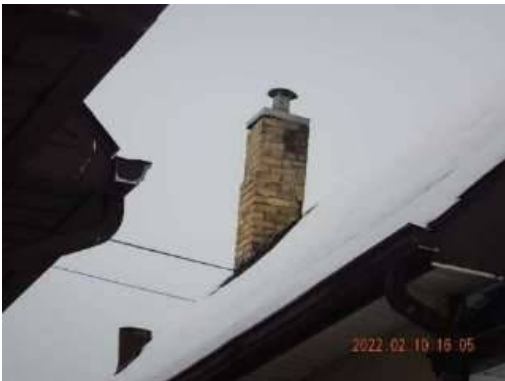
Photo 11-1

**11) Repair/Replace, Evaluate, Conducive conditions** - Flashings at the base of one or more chimneys were deteriorated. Leaks can occur as a result. This is a conducive condition for wood-destroying organisms. Recommend that a qualified contractor evaluate and repair as necessary.

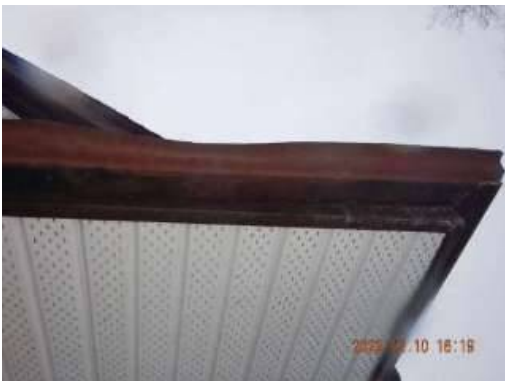
Photo 12-1

**12) Repair/Maintain, Conducive conditions** - One or more gutters were damaged. Rainwater can come in contact with the building exterior or accumulate around the building foundation as a result. This is a conducive condition for wood-destroying organisms. Recommend that a qualified person repair as necessary.

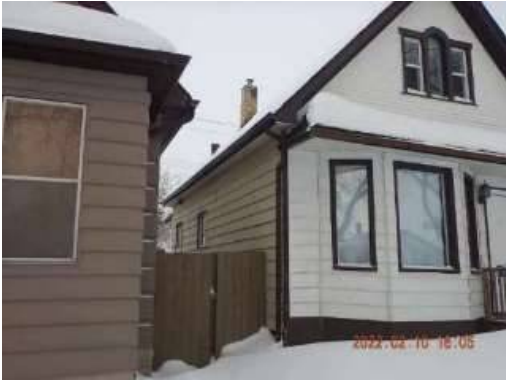
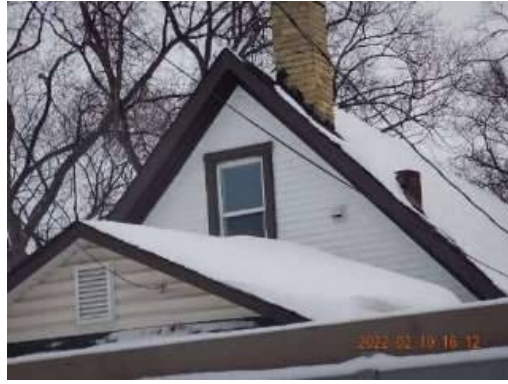
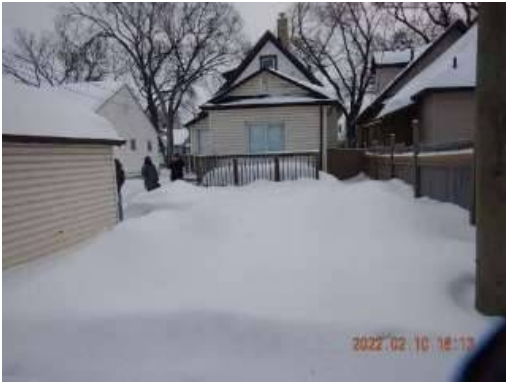
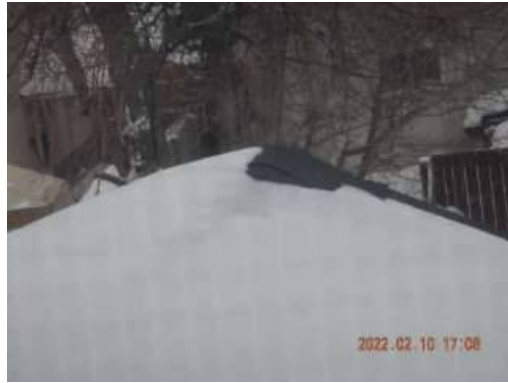
**13) Comment** - All roof surfaces were obscured by snow and couldn't be evaluated. These areas are excluded from this inspection.

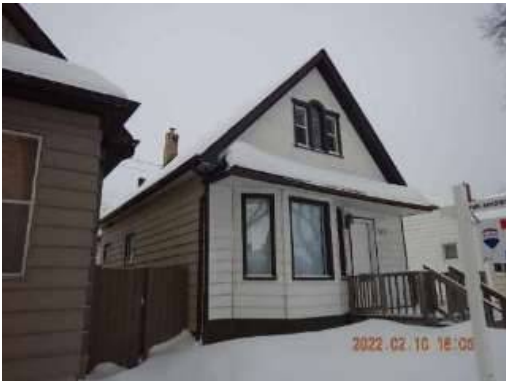
Photo 14-1

**14) Comment** - Normally the inspector attempts to traverse roof surfaces during the inspection. However, due to type of roof covering (slippery or fragile), roof configuration (steep or very high) and/or slippery conditions, the inspector was unable to traverse the roof and wasn't able to fully evaluate the entire roof surface.

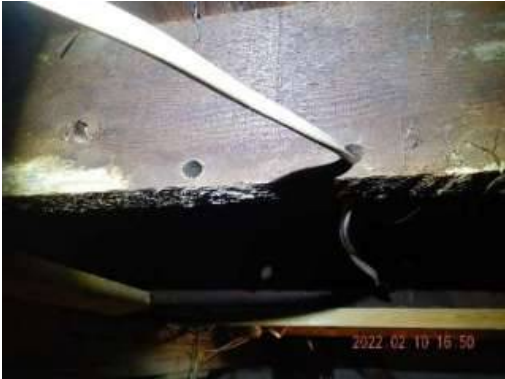
Photo 16-1

**16) Repair/Replace** - One or more joists were notched or had holes cut in them in such a way as to significantly weaken the joist(s). General guidelines for modifying joists made of dimensional lumber include these restrictions:

- Notches at ends should not exceed 1/4 of the joist's depth.
- Other notches should not exceed 1/6 of the joist's depth.
- Notches should not be cut in the middle 1/3 of the joist's span.
- Notches should not be longer than 1/3 of the joist's depth.
- Holes must be 2 inches or more from the joist's edge.
- The maximum hole diameter is 1/3 of the depth of the joist.

Recommend that a qualified contractor evaluate and repair as necessary, and per standard building practices.

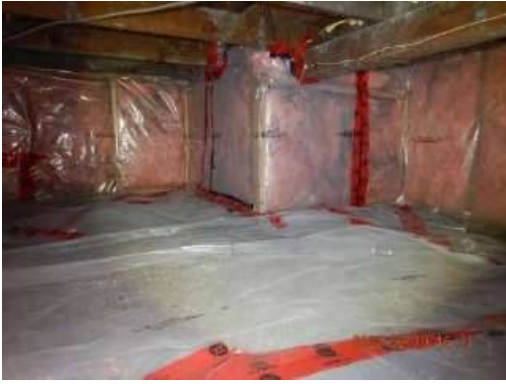
Photo 17-1

**17) Repair/Maintain** - Under-floor insulation was missing in some unheated basement and/or crawlspace areas. This may result in reduced energy efficiency. Recommend that a qualified person repair or replace insulation as necessary.

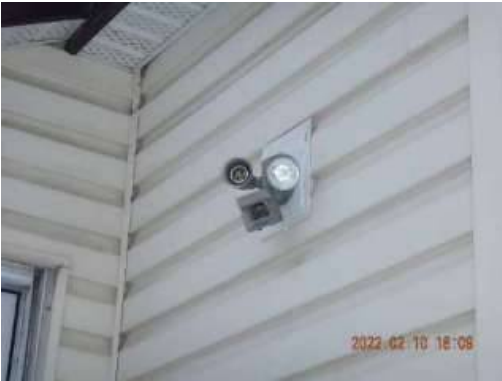
**Photo 18-1**

**18) Safety, Repair/Replace** - One or more light fixtures installed were damaged or loose. This is a potential shock and/or fire hazard. Recommend that a qualified electrician repair as necessary.

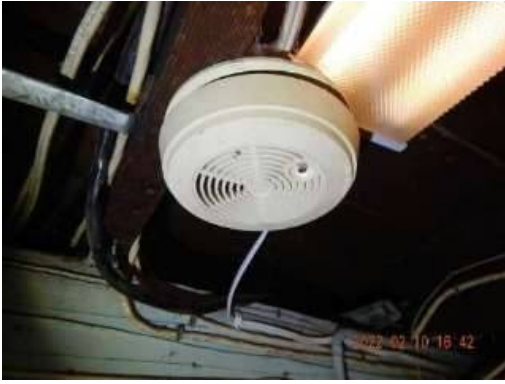
Photo 19-1

**19) Safety, Repair/Replace** - Smoke alarms were missing, old or inoperable from one or more bedrooms, from one or more hallways leading to bedrooms and/or on one or more levels. Smoke alarms should be installed as necessary so a functioning alarm exists in each hallway leading to bedrooms, in each bedroom and on each level. For more information, visit:

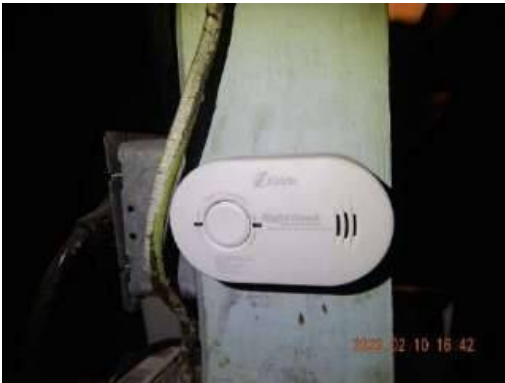
Photo 20-1

**20) Safety, Repair/Maintain** - Carbon monoxide alarms were old, missing or inoperable from one or more sleeping areas and/or on one or more levels. This is a potential safety hazard. Some states and/or municipalities require CO alarms to be installed in the vicinity of each sleeping area, on each level and in accordance with the manufacturer's recommendations. Recommend installing additional carbon monoxide alarms per these standards. For more information, visit:

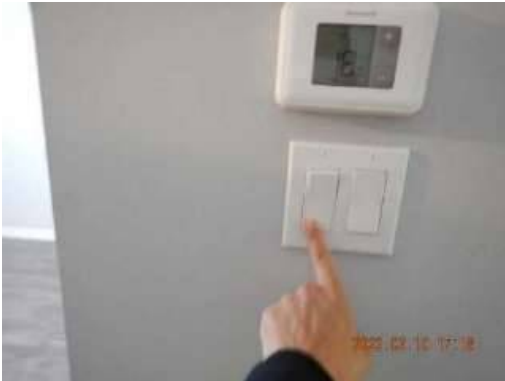
Photo 21-1

**21) Repair/Replace** - One or more wall switches were inoperable. Recommend that a qualified electrician replace wall switches as necessary.

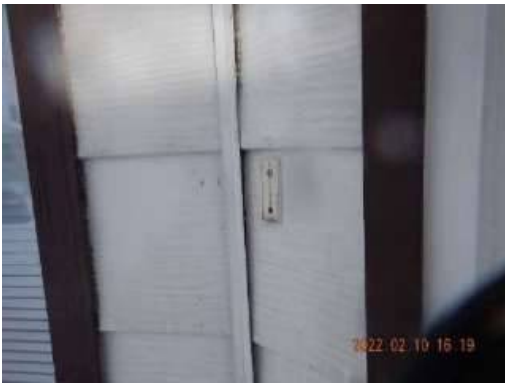
Photo 22-1

**22) Comment** - No doorbell was installed at the main entrance. The client wish to have one installed for convenience sake.

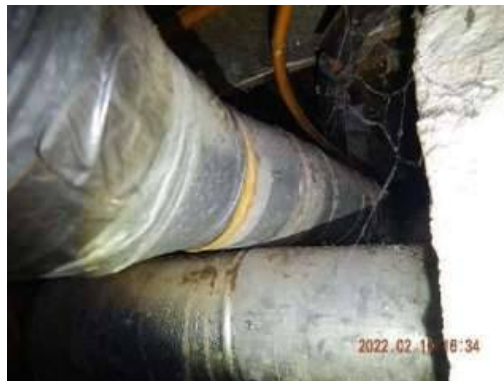
Photo 24-2

**24) Safety, Evaluate, Comment** - Possible asbestos wrap was found on some ducts for the heating system. Asbestos may pose a health hazard when airborne. If this is asbestos, in some cases, no action is needed except to leave this material undisturbed. The client may wish to have this material tested by a qualified specialist to determine if it is asbestos, and if it should be removed or encapsulated. For information on asbestos hazards in the home, visit:

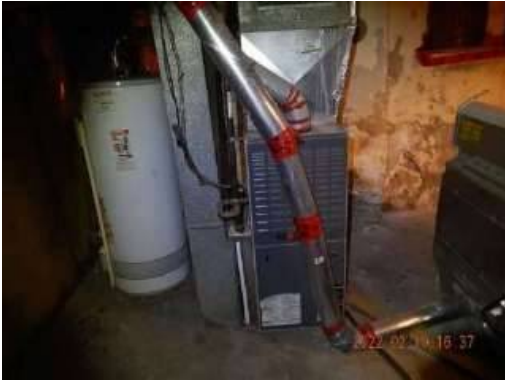
Photo 25-1

**25) Major Defect, Comment** - The estimated useful life for most forced air furnaces is 15-20 years. This furnace appeared to be near this age and/or its useful lifespan and may need replacing or significant repairs at any time. Recommend that a qualified HVAC contractor inspect and service the furnace. Note that these tests are beyond the scope of a standard home inspection.

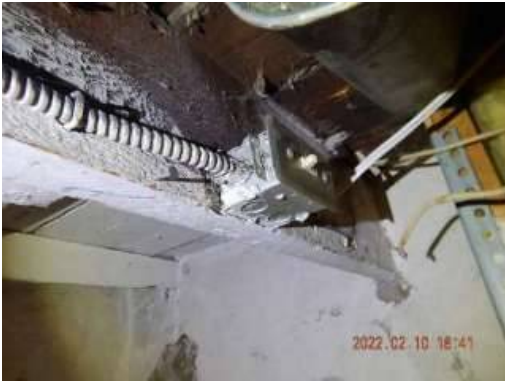
Photo 26-1

**26) Repair/Replace** - The emergency switch for the heating equipment didn't have a red cover plate or was not clearly labeled. This is a switch that allows power to be turned off quickly in the event of an emergency or servicing. Emergency switches should have a red cover plate and be clearly labeled to avoid confusion and unintentional loss of power if the switch is mistaken for a light switch. Recommend that a qualified person repair per standard building practices.

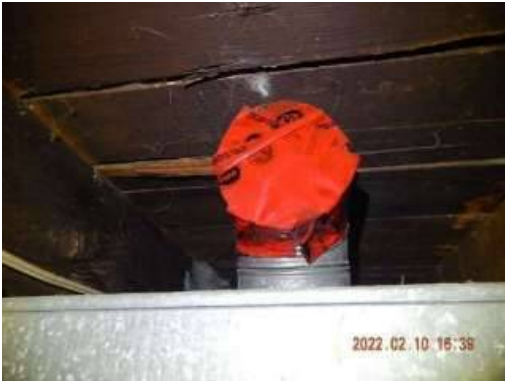
Photo 27-1

**27) Repair/Replace** - One or more heating or cooling ducts were substandard. This can result in reduced energy efficiency. Recommend that qualified HVAC contractor repair or replace ducts or components as necessary.

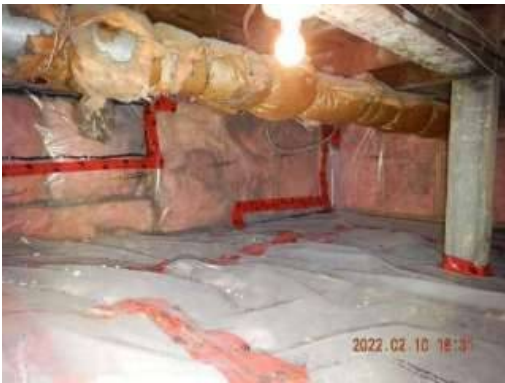
Photo 28-1

**28) Repair/Replace** - One or more heating or cooling ducts in an unconditioned space (e.g. crawl space, attic or basement) were not insulated, or the insulation was damaged or deteriorated. This can result in reduced energy efficiency, moisture inside heating ducts, and/or "sweating" on cooling ducts. Recommend that a qualified person repair per standard building practices. For example, by wrapping ducts in insulation with an R-value of R-8.

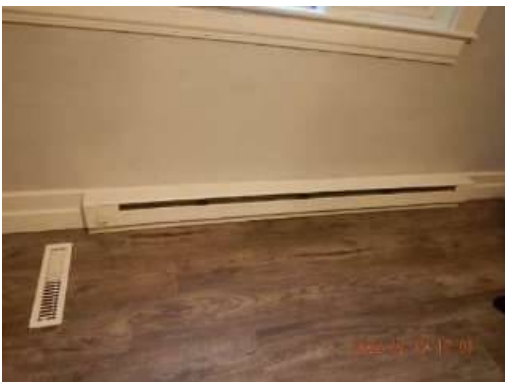
Photo 29-1

**29) Maintain** - Dirt or lint had accumulated on the fins of one or more electric baseboard heaters. This is a potential fire hazard. Recommend that a qualified person clean heaters as necessary. Note that the power to heaters must be turned off at the electric panel before cleaning them.

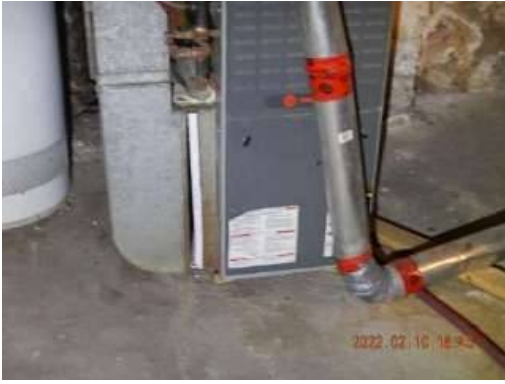
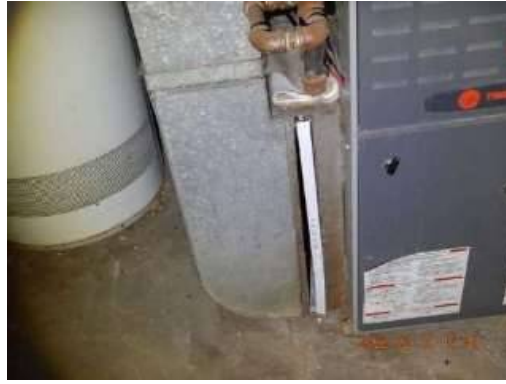
**30) Maintain** - Recommend that home buyers replace or clean HVAC filters upon taking occupancy depending on the type of filters installed. Regardless of the type, recommend checking filters monthly in the future and replacing or cleaning them as necessary. How frequently they need replacing or cleaning depends on the type and quality of the filter, how the system is configured (e.g. always on vs. "Auto"), and on environmental factors (e.g. pets, smoking, frequency of house cleaning, number of occupants, the season).

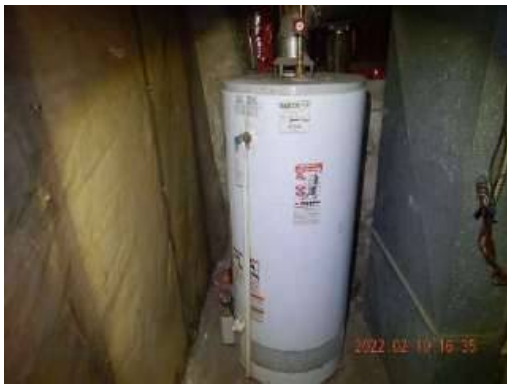
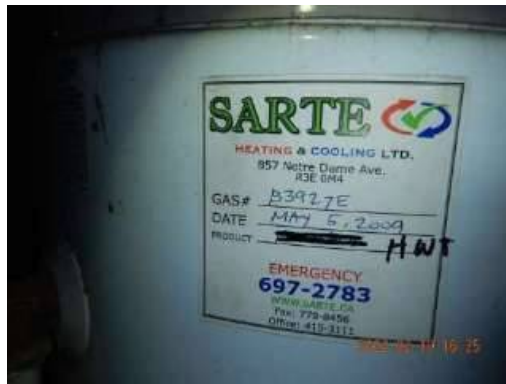
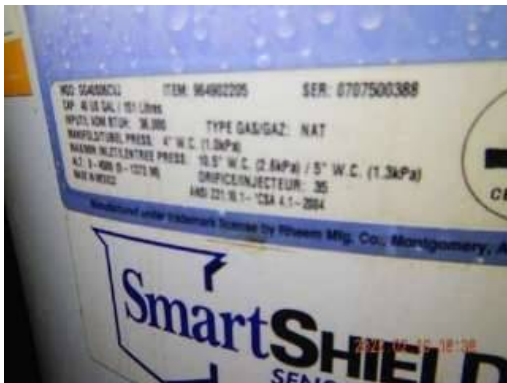
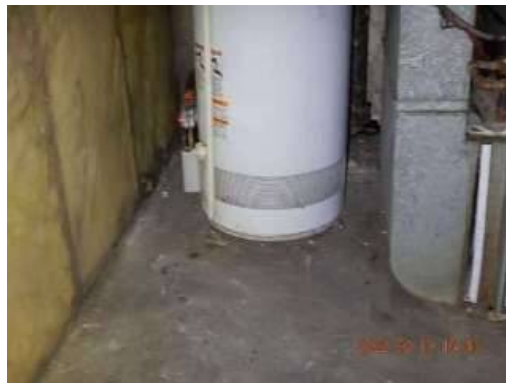
**32) Comment** - The estimated useful life for most water heaters is 8-12 years. This water heater appeared to be beyond this age and/or its useful lifespan and may need replacing at any time. Recommend budgeting for a replacement in the near future, or considering replacement now before any leaks occur. The client should be aware that significant flooding can occur if the water heater fails. If not replaced now, consider having a qualified person install a catch pan and drain or a water alarm to help prevent damage if water does leak.

Remember to place the new domestic hot water tank over a protective pad.

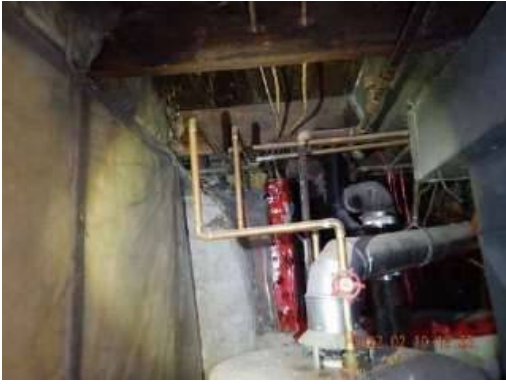
Photo 33-1

**33)** - The hot water pipe is not insulated and energy efficiency may be reduced. Recommend installing at least 1m (3 ft) long pipe insulation for better energy efficiency.

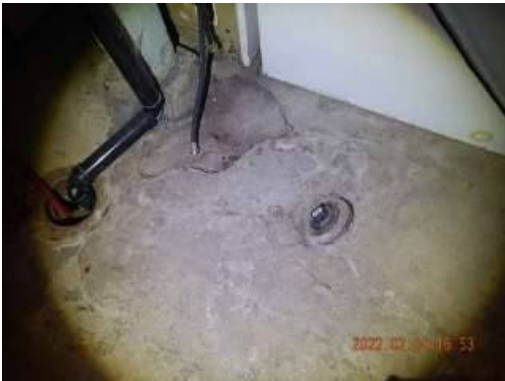
Photo 34-1

**34) Evaluate** - Based on the age of this structure, recommend that a qualified plumber inspect the waste lines using a video scope device to determine if they need repair or replacement. Property owners are usually responsible for repairs to the side sewer and publicly owned lateral lines. Such repairs can be expensive.

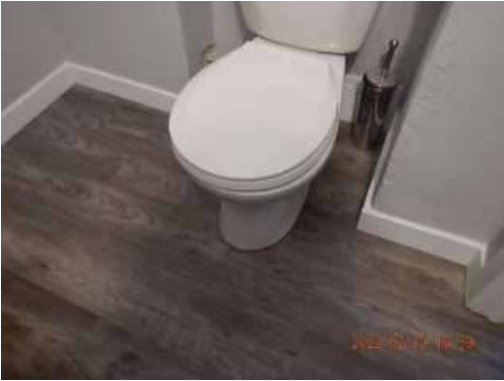
**Photo 35-1**

**35) Repair/Replace, Evaluate** - The toilet at location(s) #A had substandard caulking at base.

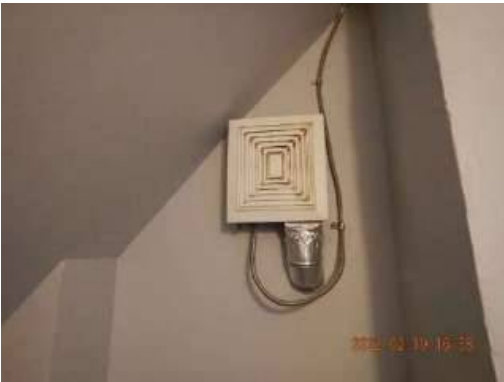
**Photo 36-1**

**36) Repair/Replace** - The exhaust fan at location(s) #B was noisy or vibrated excessively. Moisture may accumulate and result in mold, bacteria or fungal growth. Recommend that a qualified person clean, repair or replace fans as necessary.

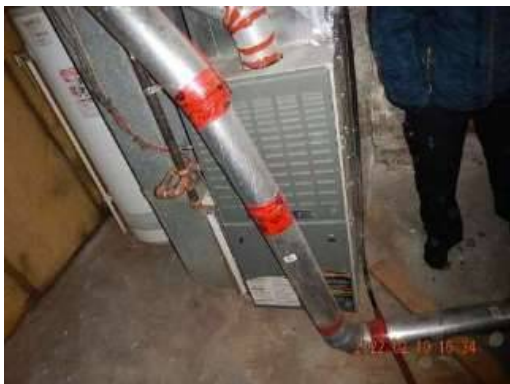
Photo 37-1

**37) Repair/Maintain** - The clothes dryer exhaust duct was routed through an unheated space (e.g. crawl space, basement, attic) and was not insulated. Condensation can accumulate inside the duct. In extreme cases ducts can be blocked by pooled water. Recommend that a qualified person permanently install R-4 insulation around the duct per standard building practices.

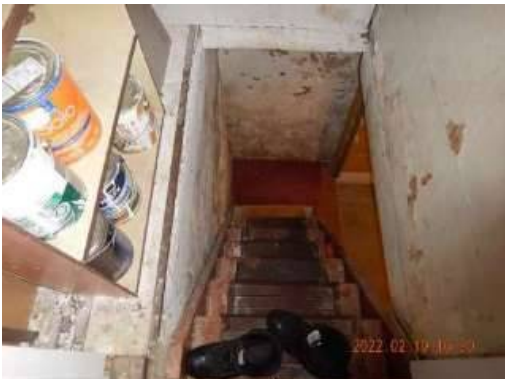
Photo 38-1

**38) Safety, Repair/Replace** - Handrails at one or more flights of stairs were missing. This is a potential fall hazard. Handrails should be installed at stairs with four or more risers or where stairs are greater than 30 inches high. Recommend that a qualified contractor install handrails where missing and per standard building practices.

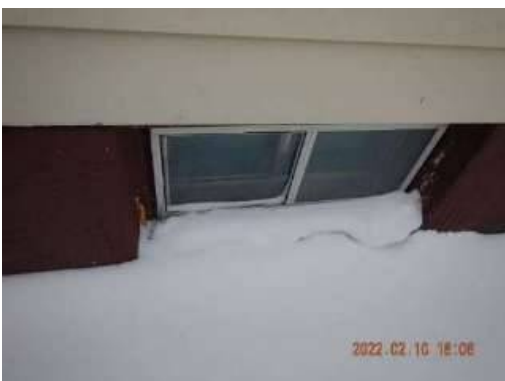
Photo 39-1

**39) Repair/Replace** - One or more windows that were designed to open and close were stuck shut. Recommend that a qualified person repair windows as necessary so they open and close easily.

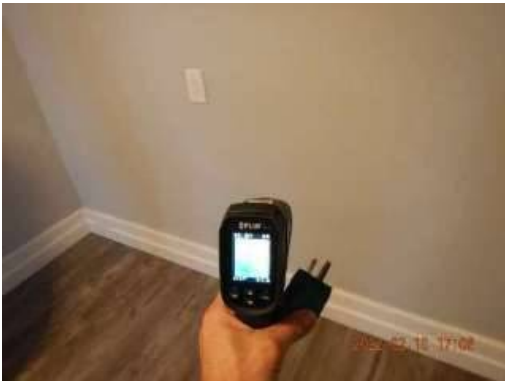
Photo 40-1

40) **Repair/Replace** - One or more walls had substandard insulation. Recommend that a qualified person repair as necessary.

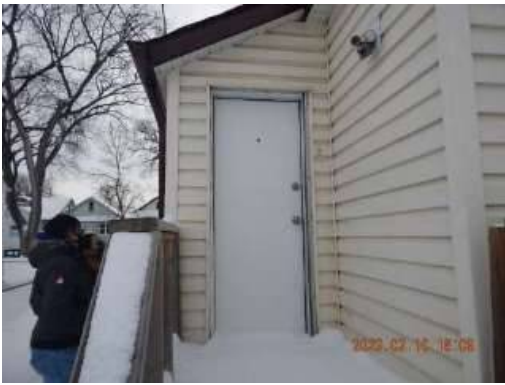
Photo 41-1

41) **Repair/Maintain** - Weatherstripping and/or threshold around one or more exterior doors was substandard. Water may enter the building, or energy efficiency may be reduced. Recommend that a qualified person repair or replace weatherstripping as necessary.

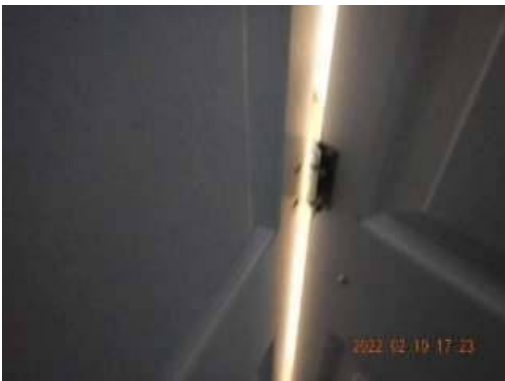
Photo 42-1

42) **Repair/Maintain** - One or more interior doors, jambs, and/or hardwares were loose. Recommend that a qualified person repair or replace as necessary.

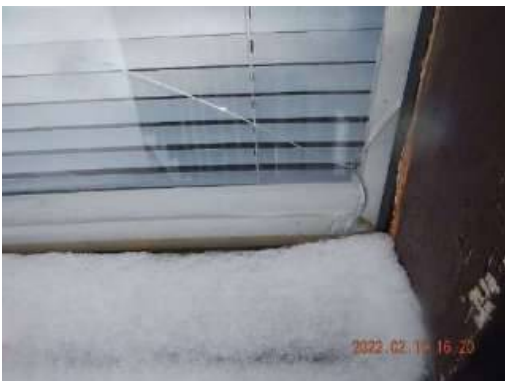
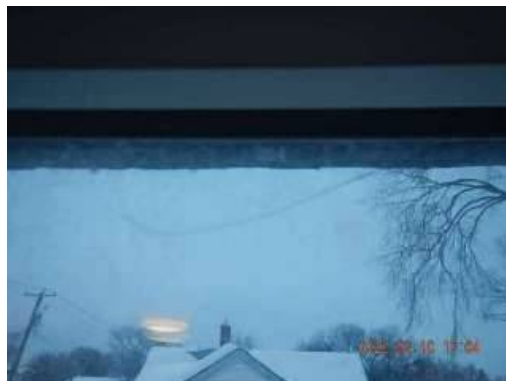
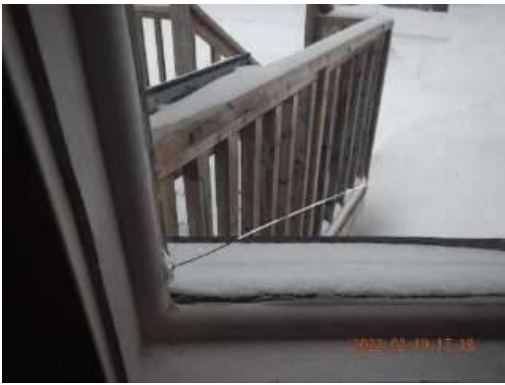
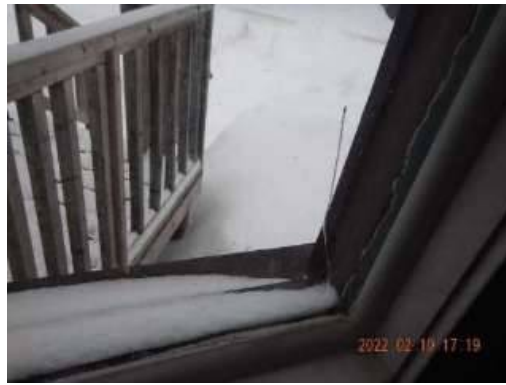
43) - Replace broken glazing

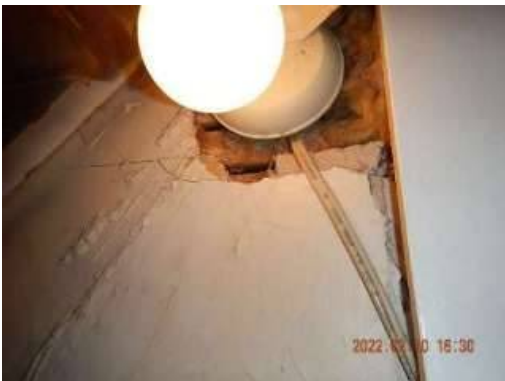
Photo 44-1

44) - Repair wall portion
